13 July 2023

**URGENT: MEDICAL DEVICE CORRECTION**  
**Plum 360 Infusion System – Audible Alarm**  
**List Number 30010**

## **Plum 360 Infusion System – Audible Alarm List Number 30010**

### **Urgent: Medical Device Correction Frequently Asked Questions**

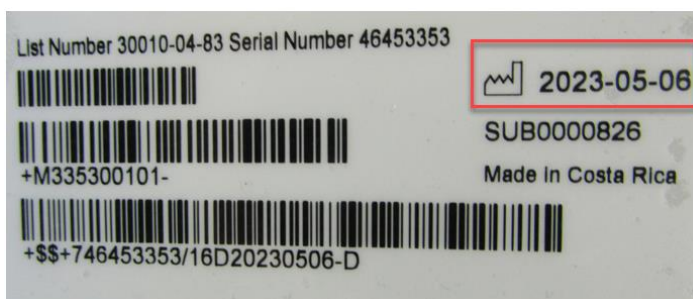
This issue affects all Plum 360 pumps manufactured between July 2020 and December 2021. The manufacturing date is shown on the Product Identification label on the side of the pump, as shown in Figure 1 below.

**Figure 1. Sample label showing Manufacturing Date in the red box – date format is shown in YYYY-MM-DD**

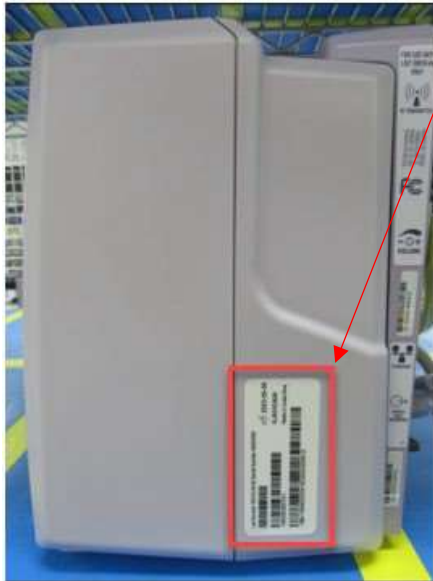
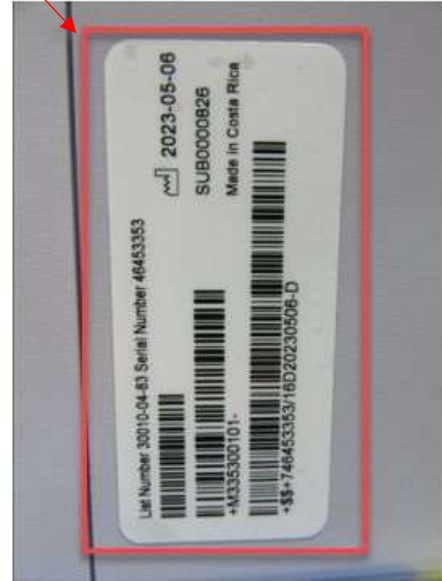
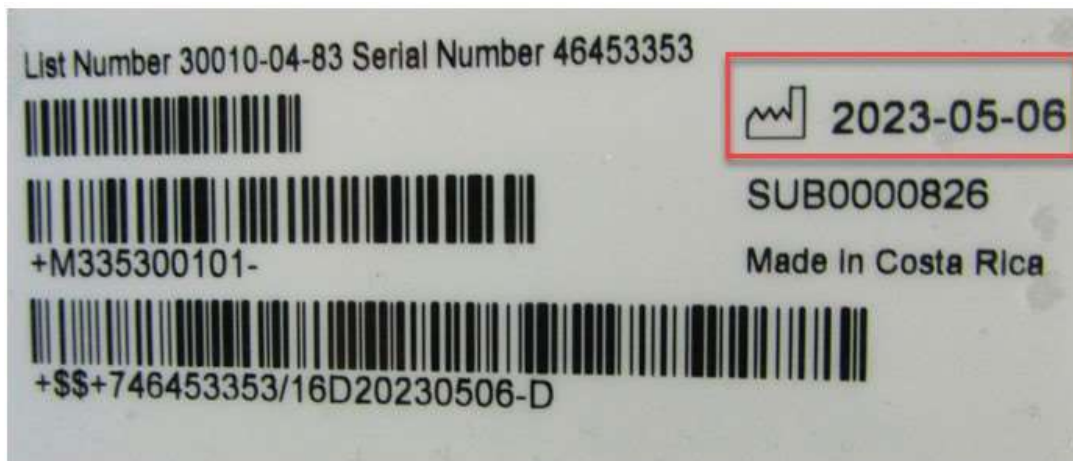
The manufacturing date is shown on the Product Identification label on the side of the pump. If the manufacturing date on the label falls between July 2020 and December 2021, the pump may be potentially affected by this issue.

The Product Identification Label can be found on the side of the pump.
