URGENT: MEDICAL DEVICE CORRECTION
Level 1® H-2 Pressure Chambers

29 July 2022

Smiths Medical is issuing this letter to notify you of a potential issue with specific Level 1® H-2 Pressure Chambers that are used with the Level 1® Fast Flow Fluid Warmers. This letter details the potential issue, the affected models, and the required steps to perform.

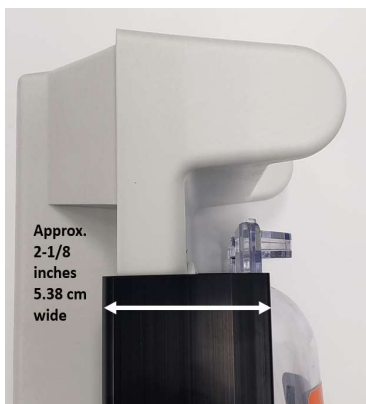
Smiths Medical implemented a design change (since 2015) to widen the hinge/latch assembly on the Level 1 H-2 Pressure Chambers used with the Level 1 Fast Flow Fluid Warmers (Models H-1025 or H-1200) or added to the H-1000 model. Smiths Medical has become aware that Level 1 H-2 Pressure Chambers with the wider hinge/latch assembly can potentially impact the amount of pressure exerted onto the IV fluid bag while contained within the pressure chamber. This may result in decreased flow rate, stopped flow, or residual fluid left within the IV bag.

Level 1 H-2 Pressure chambers with the wide hinge/latch assembly are more susceptible to this issue in the following scenarios:

- 1) kinked tubing on the disposable administration sets.
- 2) use of the lowest flow rate disposables (DI-50, D-70, or DI-70) when delivering viscous fluids such as chilled blood from 300 mL or smaller IV bags.

**Figure 2: Wide Hinge/Latch Width 2-1/8 inches (5.38 cm)
(Affected Chambers)**

3. If the device has the wider hinge/latch assembly as shown in Figure 2, then it is **affected**, and the hinge/latch should be replaced. Smiths Medical will contact you when the replacement kit is available through the email id PressureChamberFieldCorrection@icumed.com. Until the replacement kit is available, please take the steps described below:

Smiths Medical will be providing a replacement kit to modify any affected Level 1 H-2 Pressure Chambers with a narrower hinge assembly. Smiths Medical will contact customers when replacement kits are available. In the meantime, Smiths Medical will be providing customers with a printable placard which may be secured to or displayed near the product with required key actions for users.

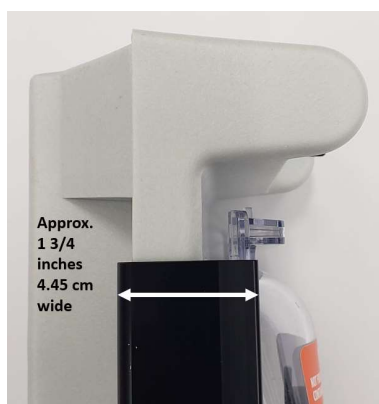
**Figure 3: Narrow Hinge/Latch Width 1-3/4 inches (4.45 cm)
(Non-Affected Chambers)**

2. If the device has the narrower hinge/latch assembly as in Figure 3, then it is not affected, and you can continue to use the device per the Operator’s Manual and IFUs.
