13 July 2023

**URGENT: MEDICAL DEVICE CORRECTION**  
**Plum 360 Infusion System – Audible Alarm: Service Replacement**  
**List Number 30010**

## **Plum 360 Infusion System – Audible Alarm List Number 30010**

### **Urgent: Medical Device Correction Frequently Asked Questions**

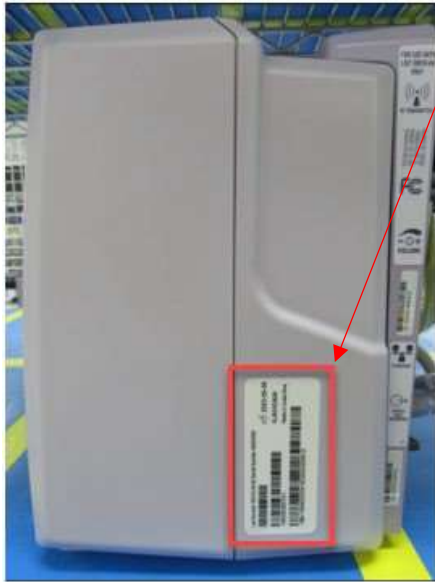
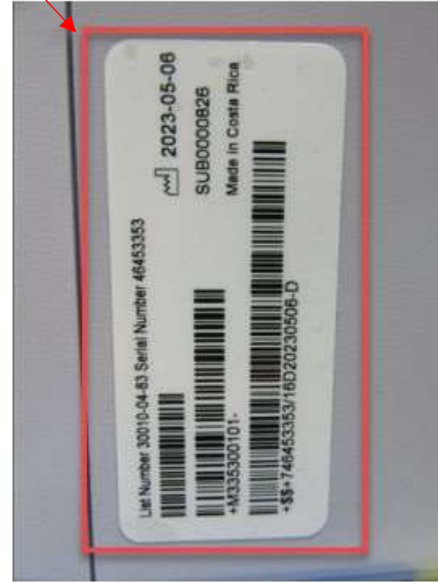
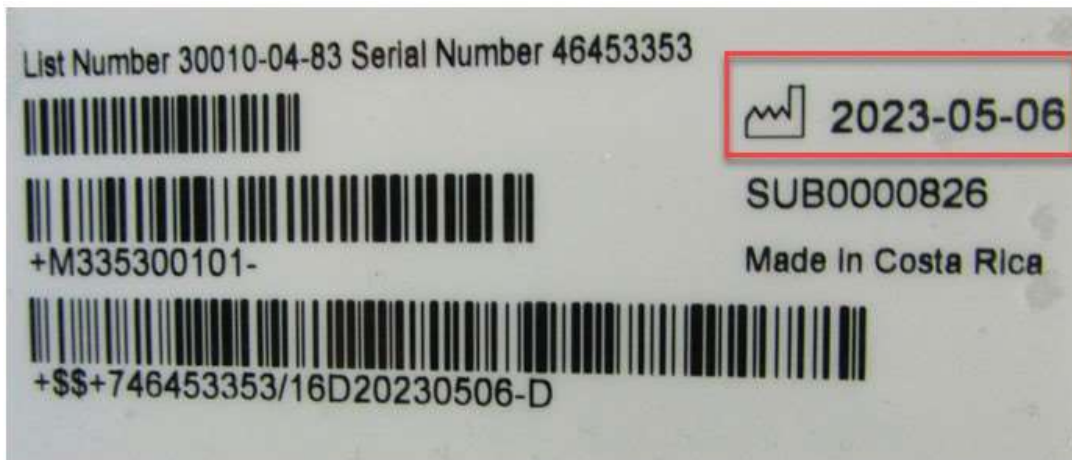
The manufacturing date is shown on the Product Identification label on the side of the pump. If the manufacturing date on the label falls between July 2020 and December 2021, the pump may be potentially affected by this issue.

The Product Identification Label can be found on the side of the pump.
