## Information Regarding Reported Black Specks in Certain IV Tubing Set Drip Chambers from ICU Medical

**Date:** 12 May 2026

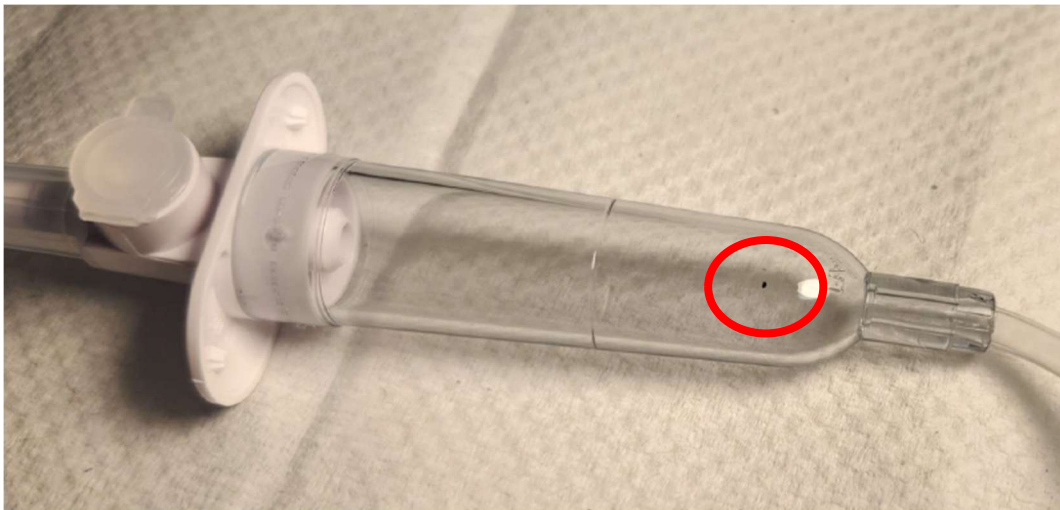
While ICU Medical has not yet received any samples for investigation, the healthcare provider conducted testing with an independent laboratory, which confirmed the material to be embedded and not loose in the fluid path, which is consistent with the plastic molding process. Based on prior ICU Medical technical evaluations of this visual condition and the information reviewed to date for the reported events provided by the reporting healthcare provider, the observed black specks are consistent with discolored PVC material embedded in the wall of the drip chamber (reference figure 1 below) and not loose in the fluid path. When confirmed to be embedded within the chamber wall, outside the fluid path, this condition is considered cosmetic and is not expected to affect device function or patient safety. In addition, the product is sterilized as part of the validated manufacturing process. At this time, ICU Medical or the reporting healthcare facility have not identified any evidence indicating that the reported condition represents any risk of biological contamination.

The drip chamber is manufactured in an ICU Medical facility from polyvinyl chloride (PVC) using an injection molding process. During this process, PVC resin is melted and injected into a mold to form the drip chamber. Localized thermal discoloration of the PVC resin can occasionally occur due to heat sensitivity, resulting in small dark spots being incorporated into the molded component. This type of condition is associated with the material and manufacturing process rather than the introduction of external matter.

Figure 1: Embedded black speck in the wall of the drip chamber from healthcare provider

Based on the current assessment, ICU Medical is not recommending sequestration or discontinuation of use of the lots identified in the public health alert on the basis of evaluation to date.
