UPDATE: Information Regarding Reported Black Specks in Certain IV Tubing Set Drip Chambers from ICU Medical

Date: 15 May 2026

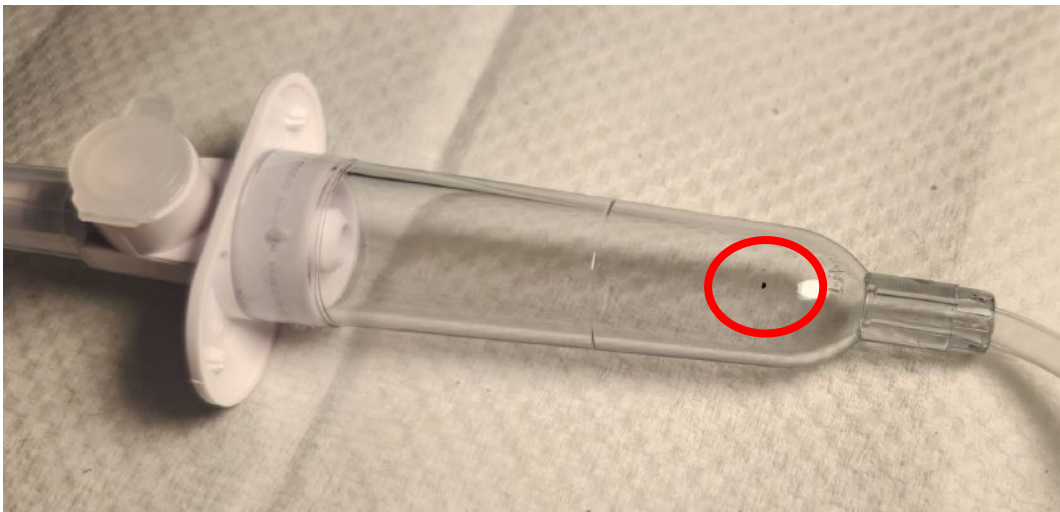
While ICU Medical is actively conducting an investigation, preliminary testing by the reporting healthcare provider suggests that in most cases the black specks appear to be embedded within the chamber wall, consistent with the plastic molding process. However, the presence of discoloration and particulate matter in the fluid path has not been ruled out. Based on ICU Medical's preliminary investigation and the information reviewed to date for the reported events provided by the reporting healthcare provider, ICU Medical considers the observed black specks, when embedded in the wall of the drip chamber (see Figure 1 below), to be consistent with discolored PVC material. At this time, neither ICU Medical nor the reporting healthcare facility have identified evidence indicating that the reported condition represents a risk of biological contamination; however, this has not been ruled out. ICU Medical is continuing the investigation and will provide updates as appropriate.

The drip chamber is manufactured in an ICU Medical facility from polyvinyl chloride (PVC) using an injection molding process. During this process, PVC resin is melted and injected into a mold to form the drip chamber. Localized thermal discoloration of the PVC resin can occasionally occur due to heat sensitivity, resulting in small dark spots being incorporated into the molded component. This type of condition is associated with the material and manufacturing process rather than the introduction of external matter.

Figure 1: Embedded black speck in the wall of the drip chamber from healthcare provider

- Users should inspect all devices prior to use for any evidence of compromise, including but not limited to marks or black specks on the chamber walls, particulate matter within the drip chamber or fluid path, and condensation within the device.
- If users visually identify any anomalies, they should segregate the individual item, complete a MedWatch complaint per the hospital facility process and contact ICU Medical to return the product sample for investigation.
- Contact ICU Medical at productcomplaintsPP@icumed.com or online at <https://icumed.custhelp.com/app/complaint> or by calling 1-(866)-216-8806 to report the event and to arrange the return of the product for investigation.
